EXISTING CONDITIONS

Physical Corridor

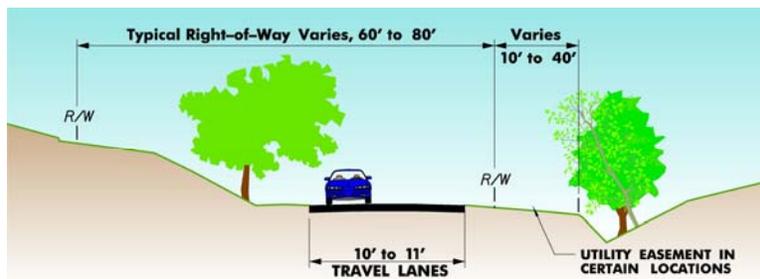
Exhibit 2 – Typical Section

The existing Lee’s Summit Road and Douglas Street typical sections include one approximately 10 foot wide travel lane in each direction, little or no shoulder, and an open ditch, typically very close to the road, to handle drainage. Due to the proximity and size of the drainage ditches along the roadway, as well as the roadway elevation, overtopping has also been known to occur in select locations. Along the majority of the roadway corridor utility poles and/or vegetation are located very close to the travel lanes, often visually confining the roadway.

The right-of-way varies throughout the corridor from as little as 45 feet (north of Lakewood Boulevard) to 90 feet (north of Phelps Road) to as wide as 120 feet (just south of US-40). The Lee’s Summit Road typical right-of-way significantly changes at 83rd Street. North of 83rd Street the typical right-of-way is approximately 50 to 60 feet, while south of 83rd Street the typical right-of-way width is approximately 75 to 80 feet. Douglas Street right-of-way within the City of Lee’s Summit is typically 80 feet.

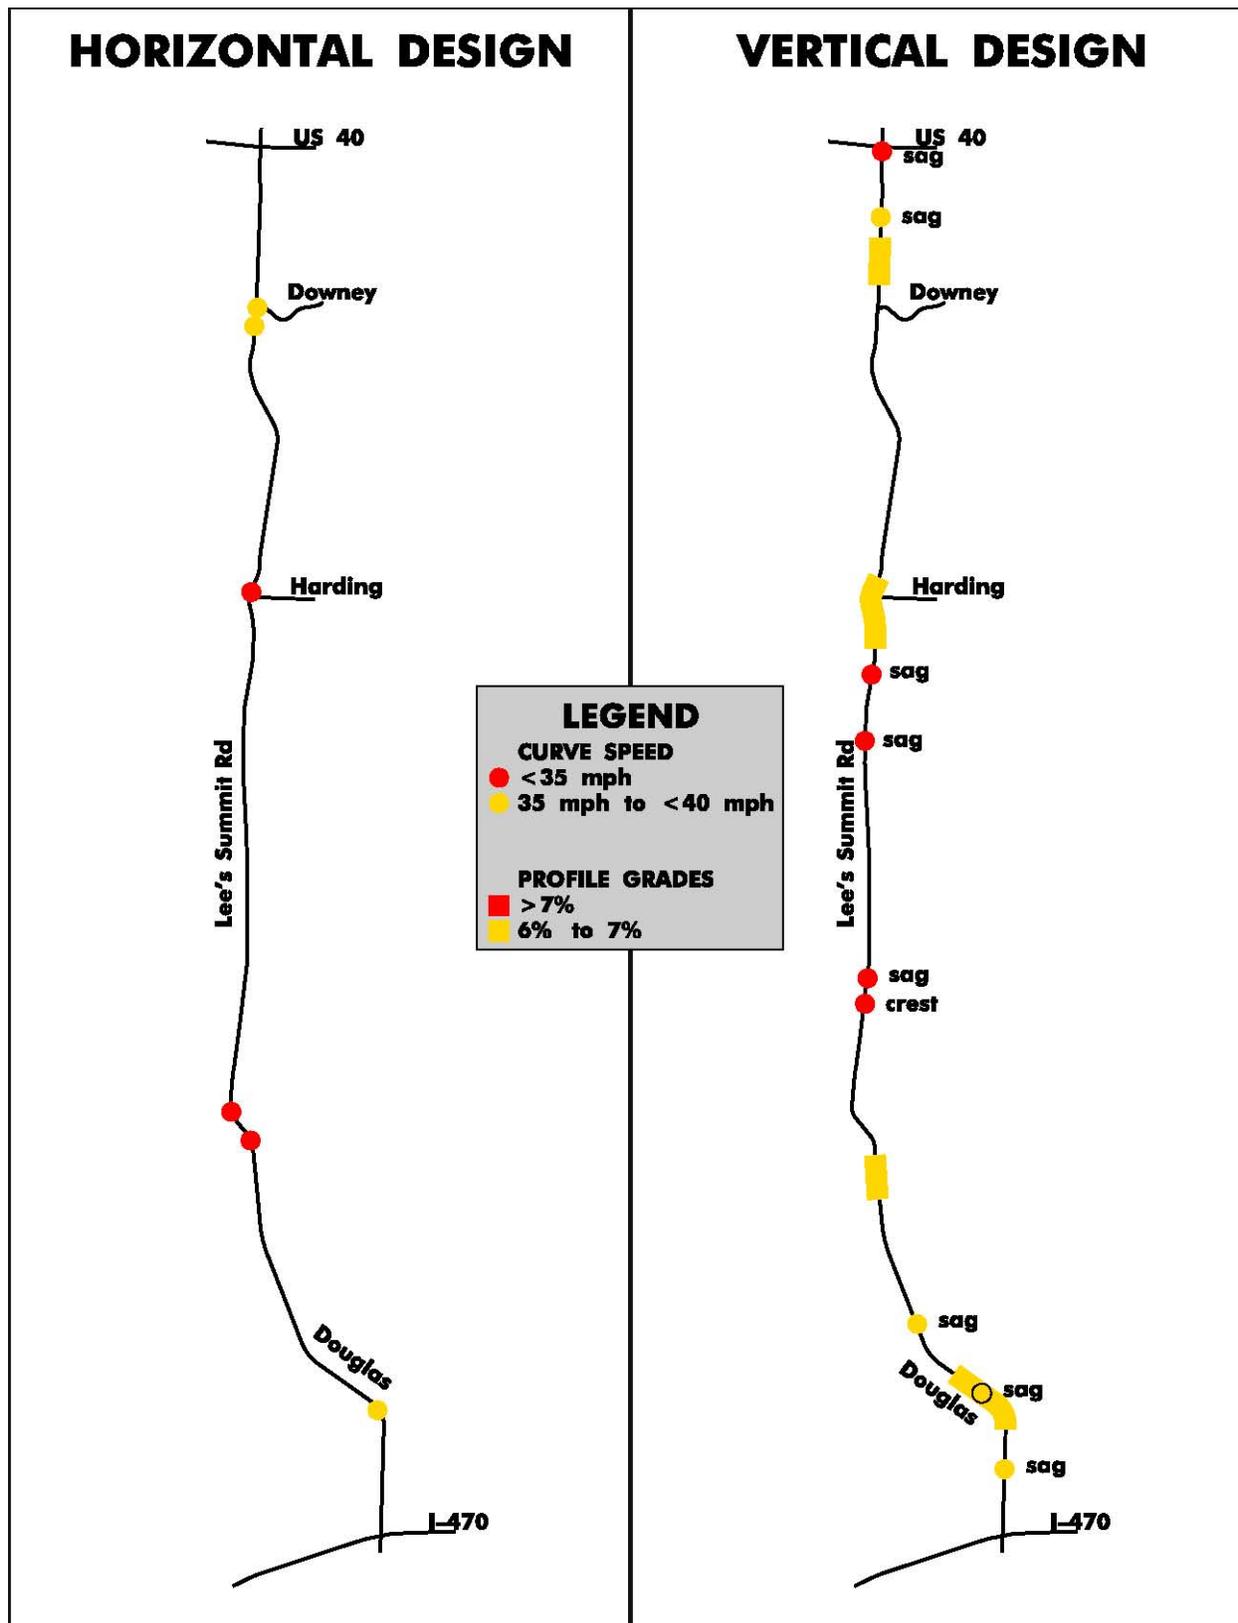
Exhibit 4 – Horizontal and Vertical Design Assessment

Exhibit 4 graphically represents the horizontal and vertical curve deficiencies for Lee's Summit Road/Douglas Street. The exhibits include red and yellow dots to represent the assessment of horizontal and vertical curves with yellow representing curves meeting a 35 mph design speed (but not the desired 40 mph) and red illustrating those with a design speed less than 35 mph. Also found on the vertical alignment exhibit are longer bands of color which represent the assessment of profile grades. For a secondary arterial standard, Kansas City lists 7% as the maximum allowable grade. Therefore, grades exceeding 7% would be shown with a red band, however none exist in this assessment, and grades between 6 and 7% are represented with a yellow band.

The vertical alignment for Lee's Summit Road/Douglas Street includes 44 vertical curves, 22 crest curves and 22 sag curves, as well as 44 total grades. Of the vertical curves, only thirteen (30%) are of sufficient length to have a design speed of 50 mph or greater. Twenty-two (50%) however, have a design speed between 40 and 50 mph. Of the nine deficient curves (20%), four have a design speed of 35 mph, and all of these are sag curves. The remaining five curves (11%) have design speeds of less than 30 mph, with three of these even less than 25 mph. This group includes the lone deficient crest curve with a design speed of less than 25 mph found near the junction of E 77th Terrace.

As stated above, none of the 44 grades along the corridor exceed the maximum recommended 7%. In fact, thirty-nine (83%) of the existing grades are less than 6%. Only five grades between 6 and 7% are present today, with only one of these grades being at or near the maximum 7%. This stretch is approximately 1,000 feet in length and is between E 83rd Street and E 85th Street. The profile from the Little Blue River south to just beyond the Space Center Driveway is essentially flat and a low area. This area has been noted as having a problem with over topping, even occasionally requiring the closure of Lee's Summit Road. This is likely due to a number of contributing factors including, the flat profile, shallow ditches, a lack of and/or blocked drainage structures, and the roadway elevation.

The existing horizontal centerline was established using the best information available during the study which essentially involved tracing the roadway's centerline (the double yellow pavement marking) from the aerial mapping. The horizontal alignment of Lee's Summit Road/Douglas Street includes 39 horizontal curves. Twenty-five of these curves (64.1%) have a design speed, based on today's design standards, exceeding 50 mph. An additional eight curves (20.5%) have a design speed between 40 and 50 mph. Three curves (7.7%) meet a 35 mph design speed while the remaining three curves (7.7%) are deficient with a design speed below 35 mph. Many of these curves are posted with warning signs. It is assumed for this assessment that curves are without superelevation as City standards do not include superelevation on horizontal curves for a secondary arterial design.

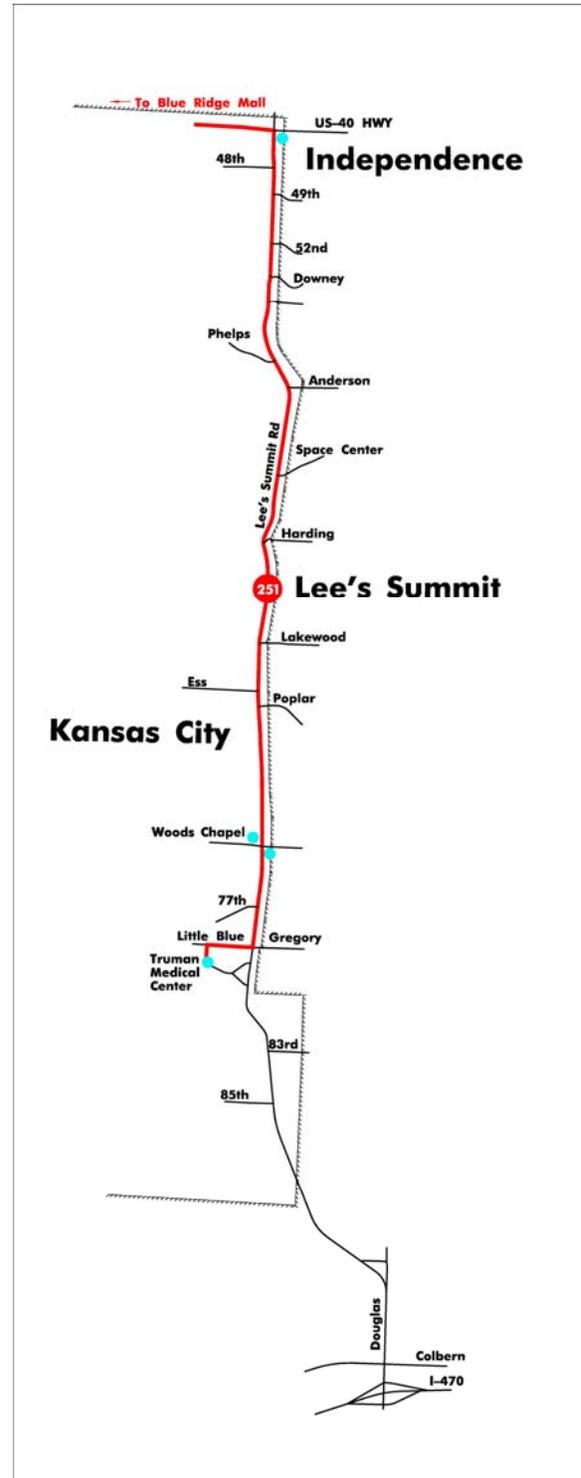
Exhibit 6 – Transit Bus Routes and Marked Stops

Transit services are provided by the Kansas City Area Transit Authority (KCATA) via bus Route 251. This route traverses between Blue Ridge Mall and Truman Medical Center (TMC) – Lakewood. Its route is primarily US-40 Highway and Lee's Summit Road. Access to TMC – Lakewood is via Little Blue Road.

Several bus stops are located along Lee's Summit Road and include marked stops at the near side approaches at Woods Chapel Road and at US-40 Highway. Unfortunately both locations are not served by sidewalks. The bus stop locations at Woods Chapel Road are essentially in the drainage ditch along the side of the road. It is also worth noting that it is possible to flag down the bus anywhere along the route, this was observed happening at the Space Center entrance. Exhibit 6 illustrates the route and marked stops for the KCATA bus Route 251.

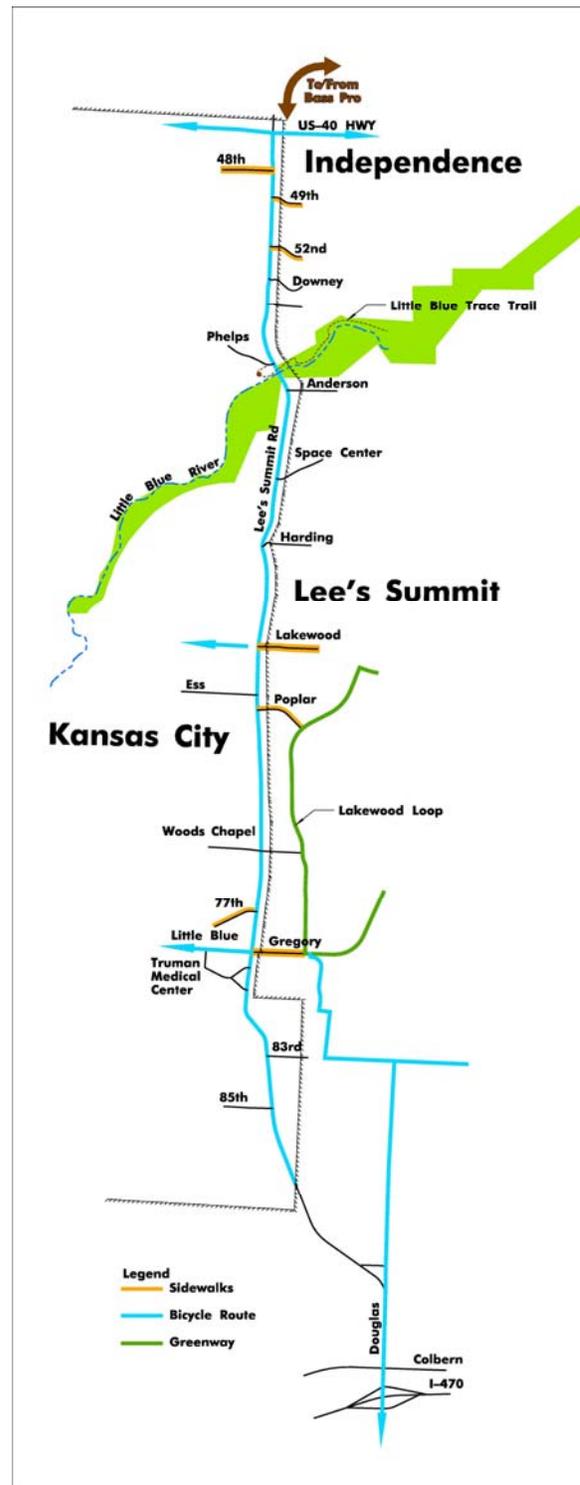
Exhibit 7 – Bicycle and Pedestrian Accommodations

Bicycles – Lee's Summit Road is shown on the City's Bicycle Route map, albeit as a planned facility. Currently no bicycle facilities or signs are provided along or across Lee's Summit Road. With a lack of shoulder and high speeds (greater than 40 mph), a review through the Bicycle Compatibility Index (BCI) would show a high level of stress, independent of traffic volumes. Several other bicycle routes are also identified and include:

Pedestrians – Only a small portion of sidewalk exists along Lee’s Summit Road, that being 200 feet on the east side, south of US-40 Highway. Side street sidewalks are also limited. The following list identifies those side streets with sidewalks that intersect with Lee’s Summit Road:

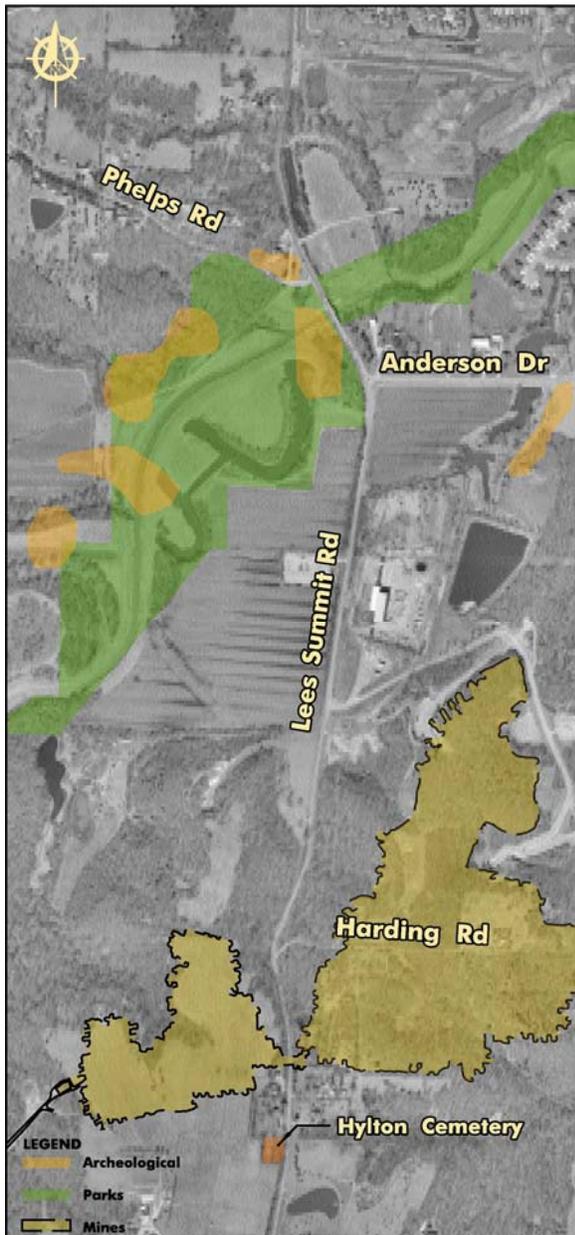
**Exhibit 12 – Public Lands (Section 6(f)),
Archeological Resources and Subsurface Mines**

- Little Blue Trace Park is located along the Little Blue River, extending from Longview Lake north to Blue Mills Rd. The 1,856 acre preserve contains a 10 mile hiking and bicycle trail, 4 shelters, 30 picnic tables, a softball field, and 3 soccer fields.

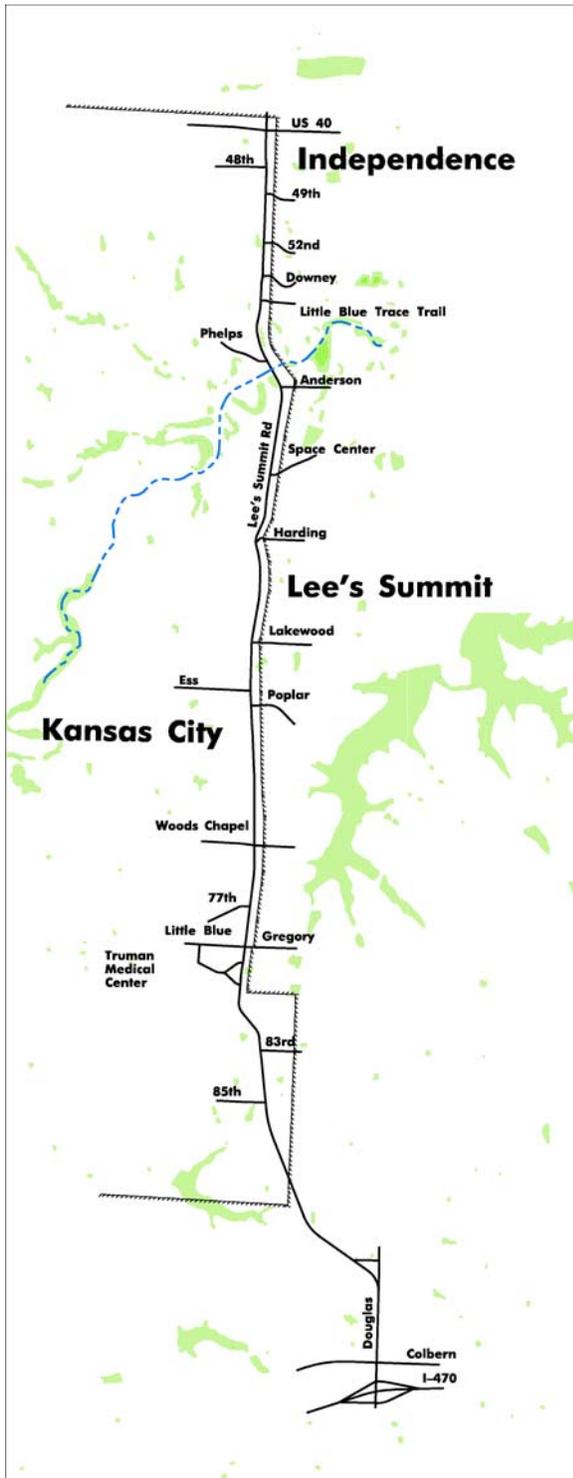
Exhibit 13 – NWI Wetlands

delineation was not to be performed for this study stage; however, a wetland delineation may need to be done prior to construction depending upon anticipated impacts. The locations of potential wetlands in the study area are indicated on Exhibit 13.

The most concentrated areas of wetland habitat lie along the Little Blue River floodway/ floodplain; these wetlands consist mainly of palustrine, emergent wetlands.

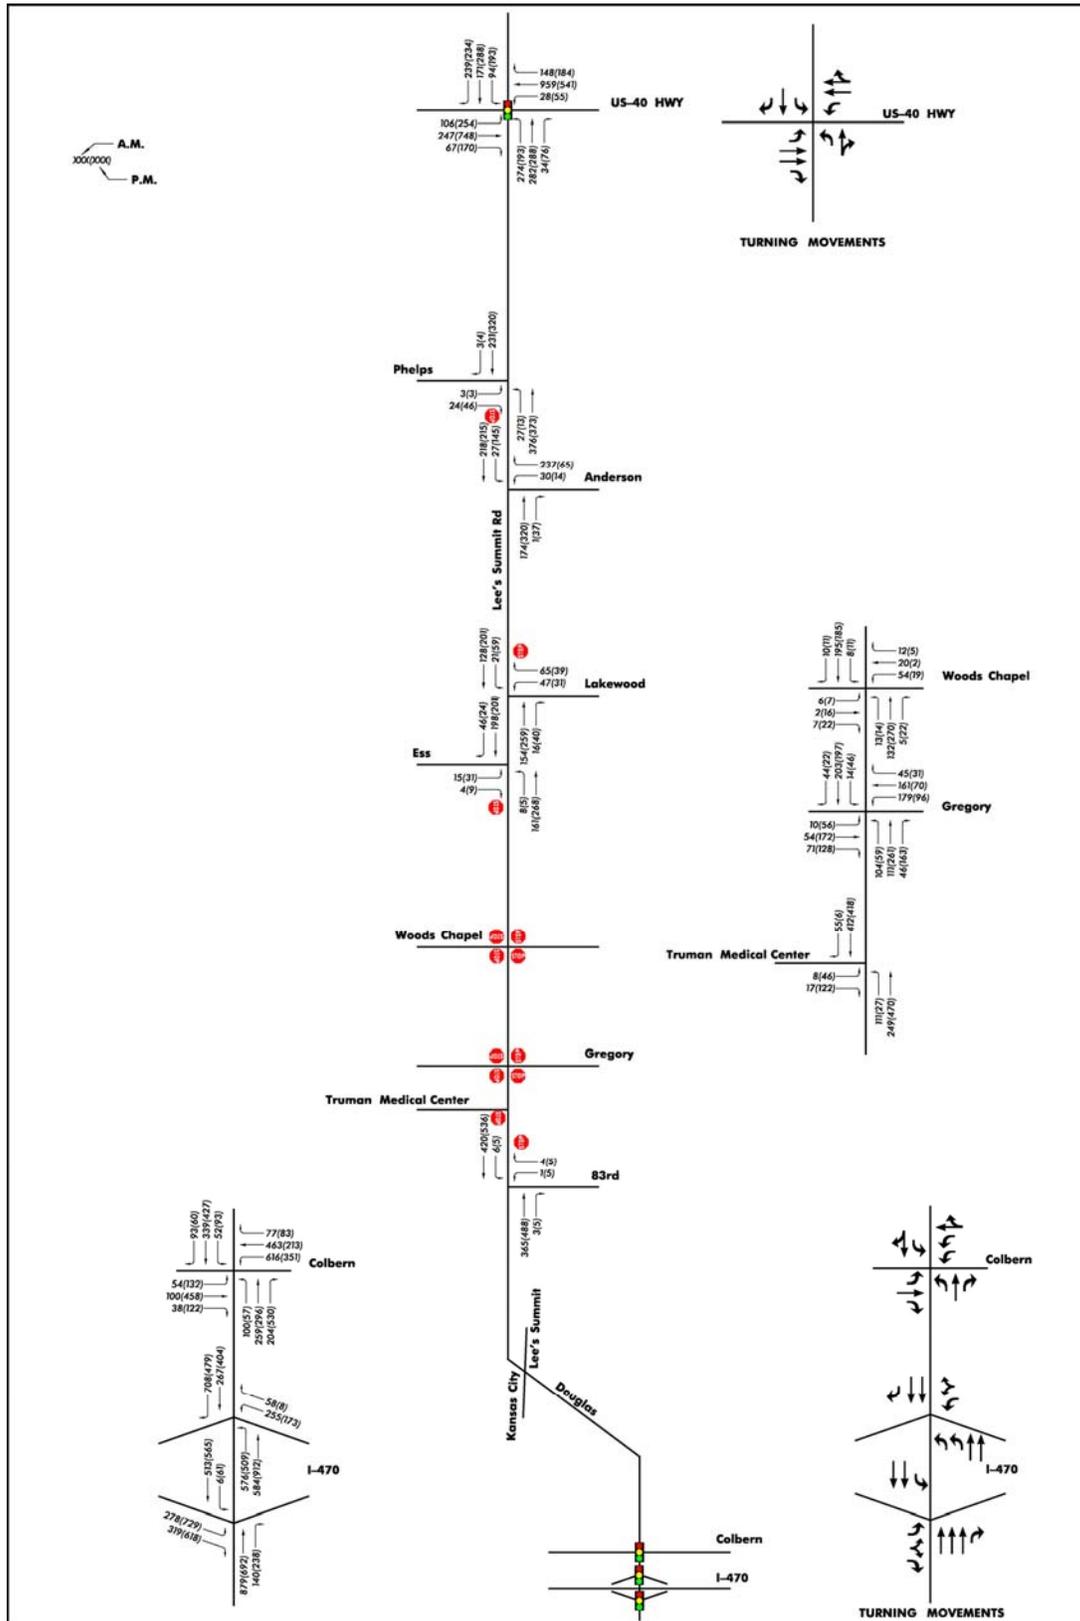
Exhibit 16 – Existing AM and PM Peak Hour Traffic Volumes and Lane Configurations

This data indicates a range of daily traffic volumes along Lee's Summit Road between 5,500 and 9,300 vehicles per day (vpd). The highest volumes are at the north and south ends of the corridor under investigation. The lowest volume is in the middle, which is an indication of several traffic sheds. Review of traffic volumes by peak directional travel confirm the notion of traffic sheds. In the AM period, traffic at the north end has a northbound directional peak while traffic at the south end in the AM period has a southbound directional peak.

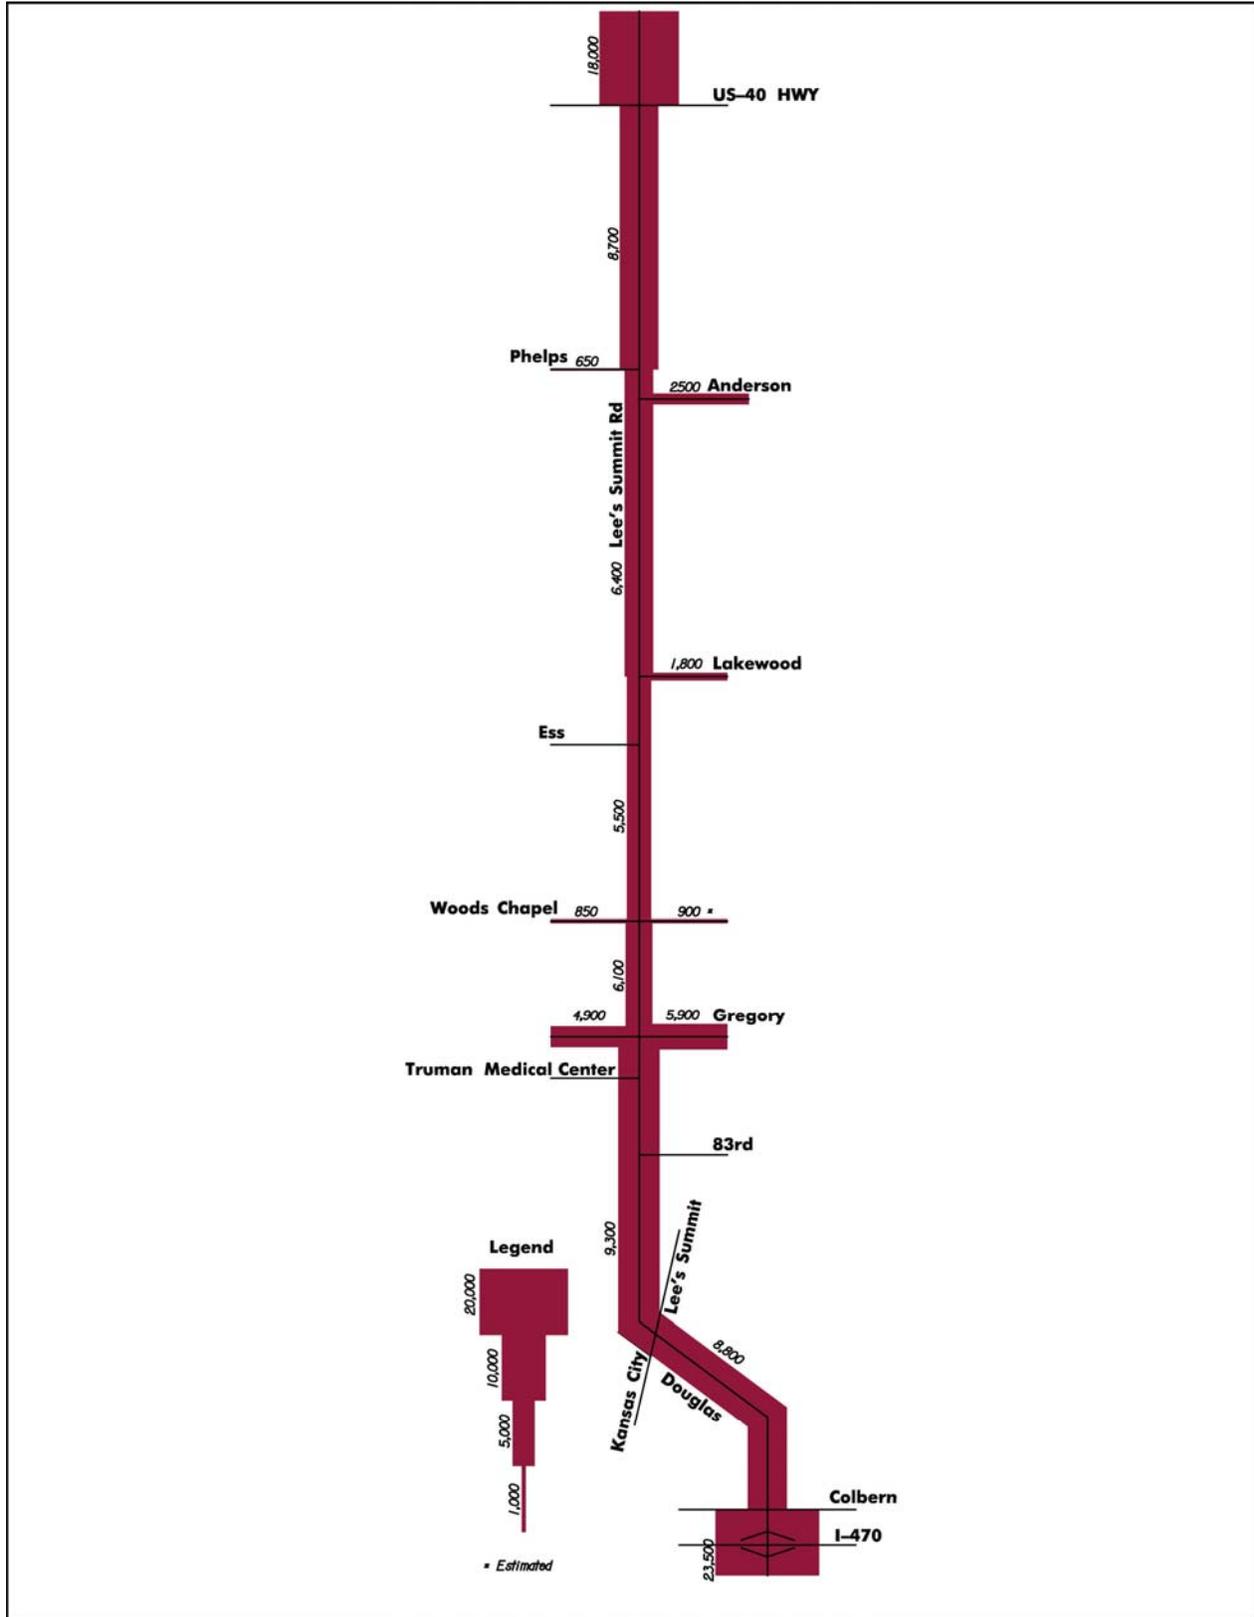
Exhibit 17 – Existing 24-Hour Traffic Volumes

Traffic volume data was collected in mid-September 2006 which included 24-hour counts at several locations along the corridor as well as turning movement counts during peak periods at critical intersections. It should be noted that there are two intersections along the corridor where existing traffic counts were conducted yet are not included within the LS TDM model; Woods Chapel Road and Ess Road. The intersection analysis utilizes these existing traffic volumes and an "off-line" estimate of future year traffic is made for these intersections. Only vehicular traffic data was collected as sidewalks are not provided, no pedestrian counts were conducted. Automatic vehicle classification counts in Independence and Lee's Summit indicate a consistent truck percentage of slightly less than 10%.

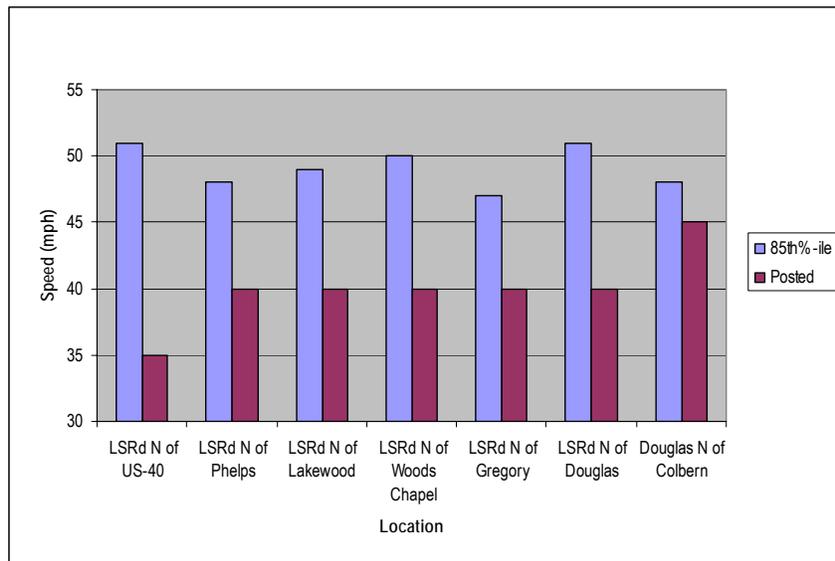
Exhibit 18 – 85th Percentile Speed

The count data collected does not calculate a direct 85th %-ile speed so a series of charts were developed to allow an estimate of the 85th percent to be determined. The range of 85th %-ile speeds range from a low of 47 mph to a high of 51 mph. It is worth noting that the posted speeds along the corridor are 35 mph north of US-40, 40 mph in Kansas City and 45 mph in Lee's Summit. Exhibit 18 lists the location of traffic counts and the 85th %-ile speed.

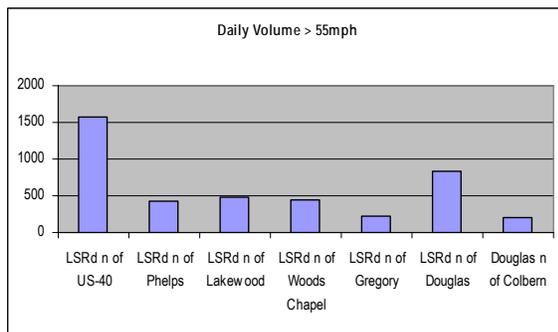
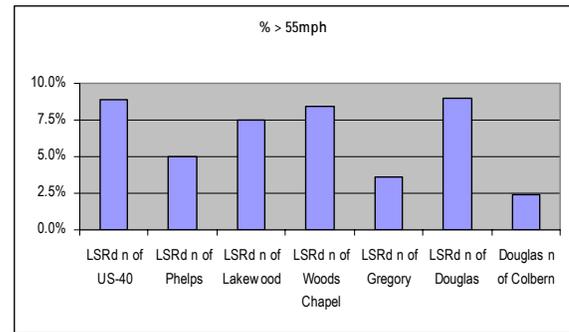
Exhibit 19 – Daily Volume and Percent > 55 mph

The highest number of vehicles traveling greater than 55 mph occurs north of US-40 at approximately 1,580 vehicles per day. The second highest is north of Douglas St at approximately 800 vehicles per day. However because traffic volumes change along the corridor, when the volumes are reviewed as a percentage, the top two locations are nearly equal at approximately 9% of the daily traffic and the location north of Woods Chapel Road is identified as a high percentage location even though its traffic volume is significantly less. This comparison is shown in Exhibit 19.

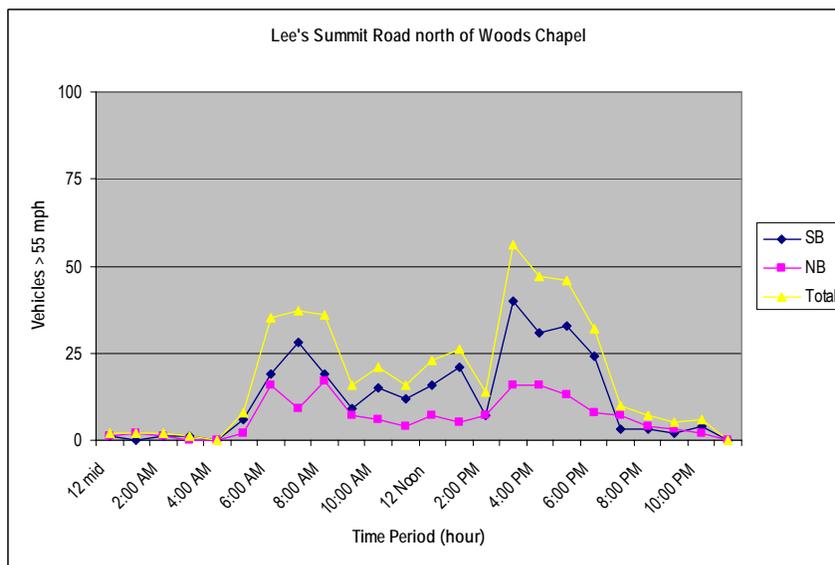
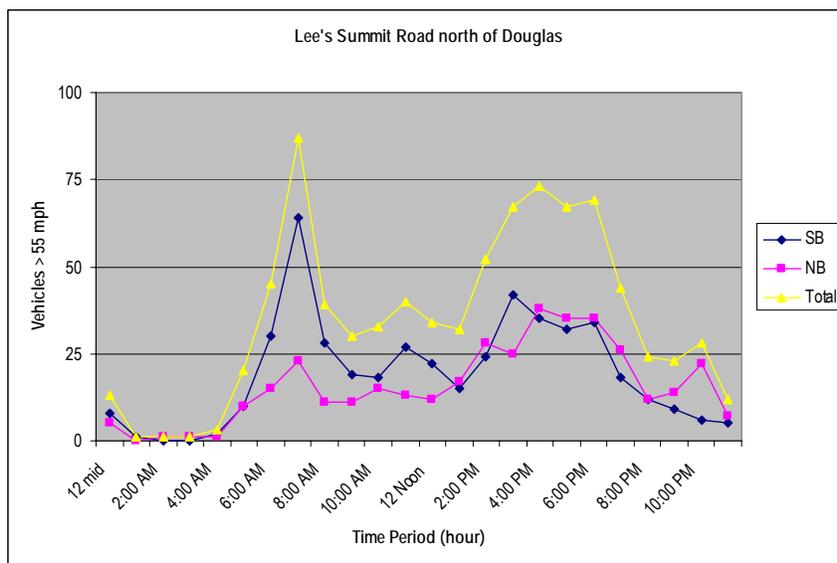
Exhibit 20 – Hourly and Directional Variation > 55 mph (Selected Locations)

The two locations of north of Douglas Street and north of Woods Chapel Road were chosen for further review by hourly distribution of traffic greater than 55 mph as well as by direction. While traffic volumes are different in the two locations general patterns are similar. For example, a higher number of vehicle travel greater than 55 mph in the AM and PM peak periods. In a more detailed review the locations differ. For example, north of Douglas the highest traffic volume traveling greater than 55 mph occurs in the AM while north of Woods Chapel that occurs in the PM. Both locations show a higher volume of traffic traveling greater than 55 mph in the southbound direction in the AM, yet in the PM north of Douglas the distribution is equal, while north of Woods Chapel southbound remains the dominant direction. This may in part be due to the location of the traffic counters and the influence of the 4-way stop at Woods Chapel Road. Graphs of these two locations are shown in Exhibit 20.

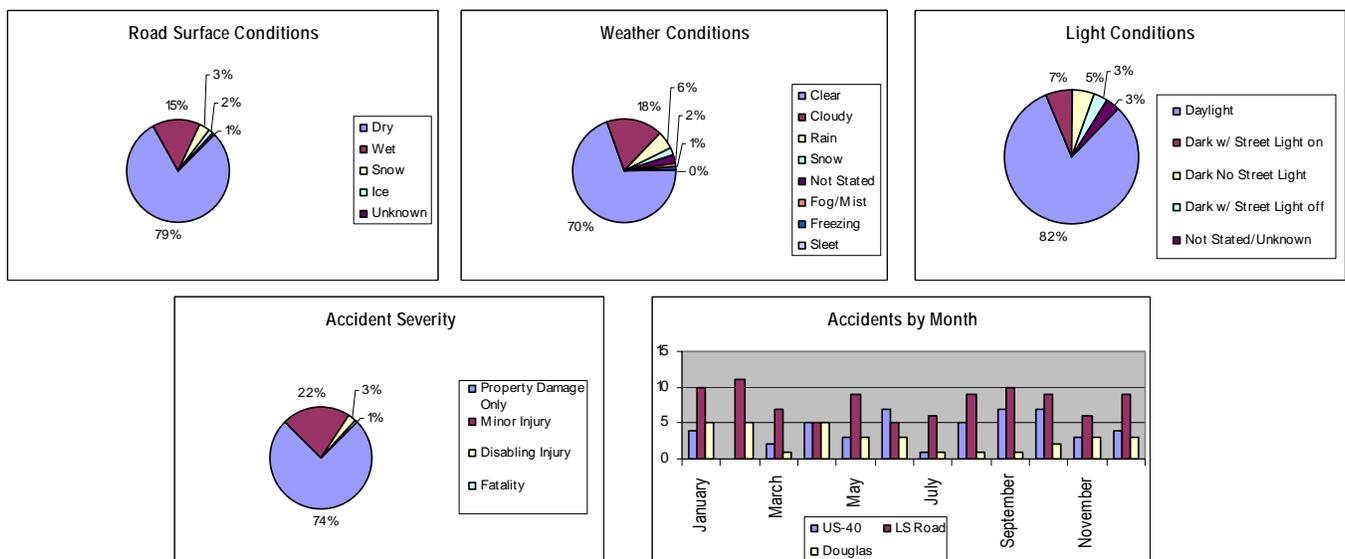
Exhibit 23 – Crash Data Summaries

Crashes are classified into one of four categories; property damage only (PDO), minor injury, disabling injury or fatal. The most prevalent accident type is PDO with an overall injury rate of 26%.

- Road Surface – The majority of crashes (79%) occur in dry conditions. Wet road conditions account for 15% of crashes.
- Weather – The majority of crashes (70%) occur under clear weather conditions although rain represents 6% of the reported crashes.
- Light – The majority of crashes (82%) occur in daylight.

The most frequent months for crashes are January, September and October. When reviewed individually, patterns are less evident. Exhibit 23 summarizes this crash data.

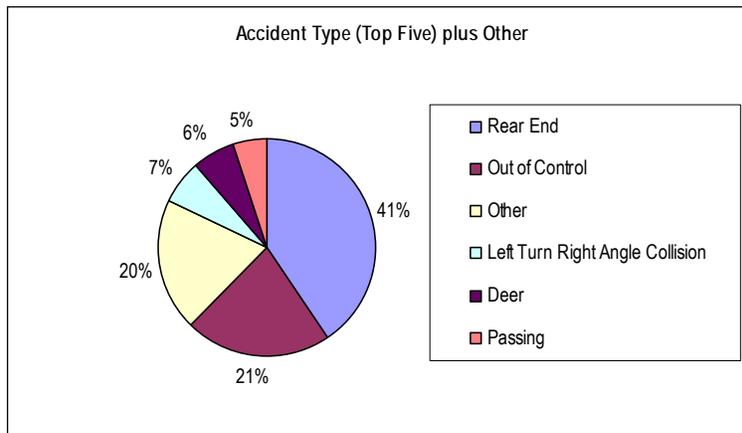
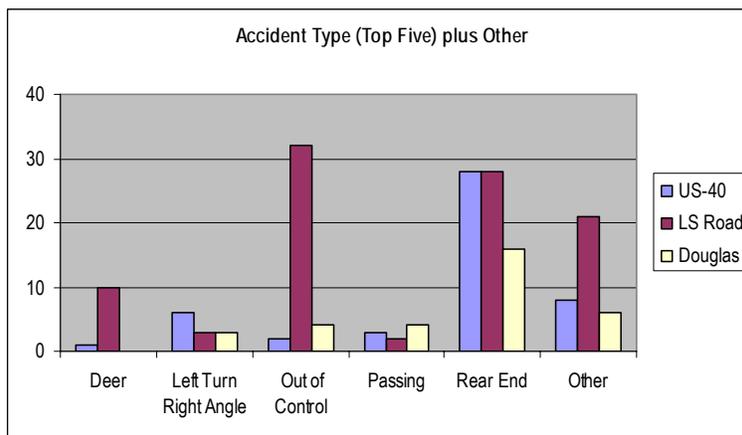
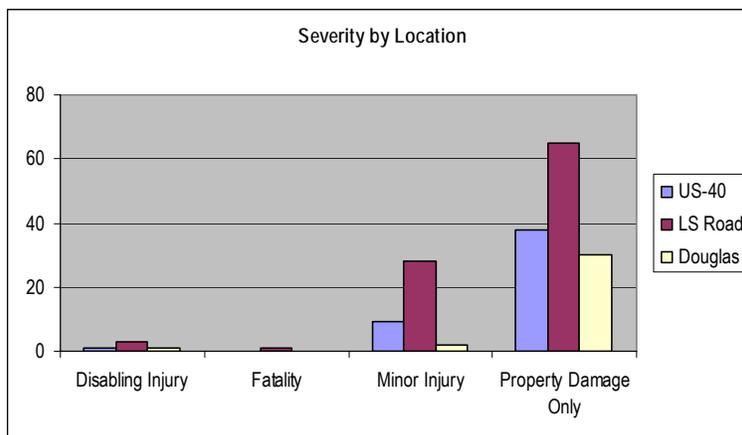
Exhibit 24 – Crash Types and Severity

The top five types of crashes account for 80% of all crashes. Overall, rear end accidents are the most prevalent. Yet by location, out-of-control accidents are the most common along Lee's Summit Road. During the three year period (2002 through 2005) only one fatal accident occurred. Over the ten year period from 1996 through 2005, a total of four fatal accidents occurred. Three of these four fatal accidents were attributed to out-of-control. Exhibit 24 summarizes the crashes by type and severity.
